# PRESERVING PETRA THE CRUMBLING CITY OF STONE

by Tina Luton

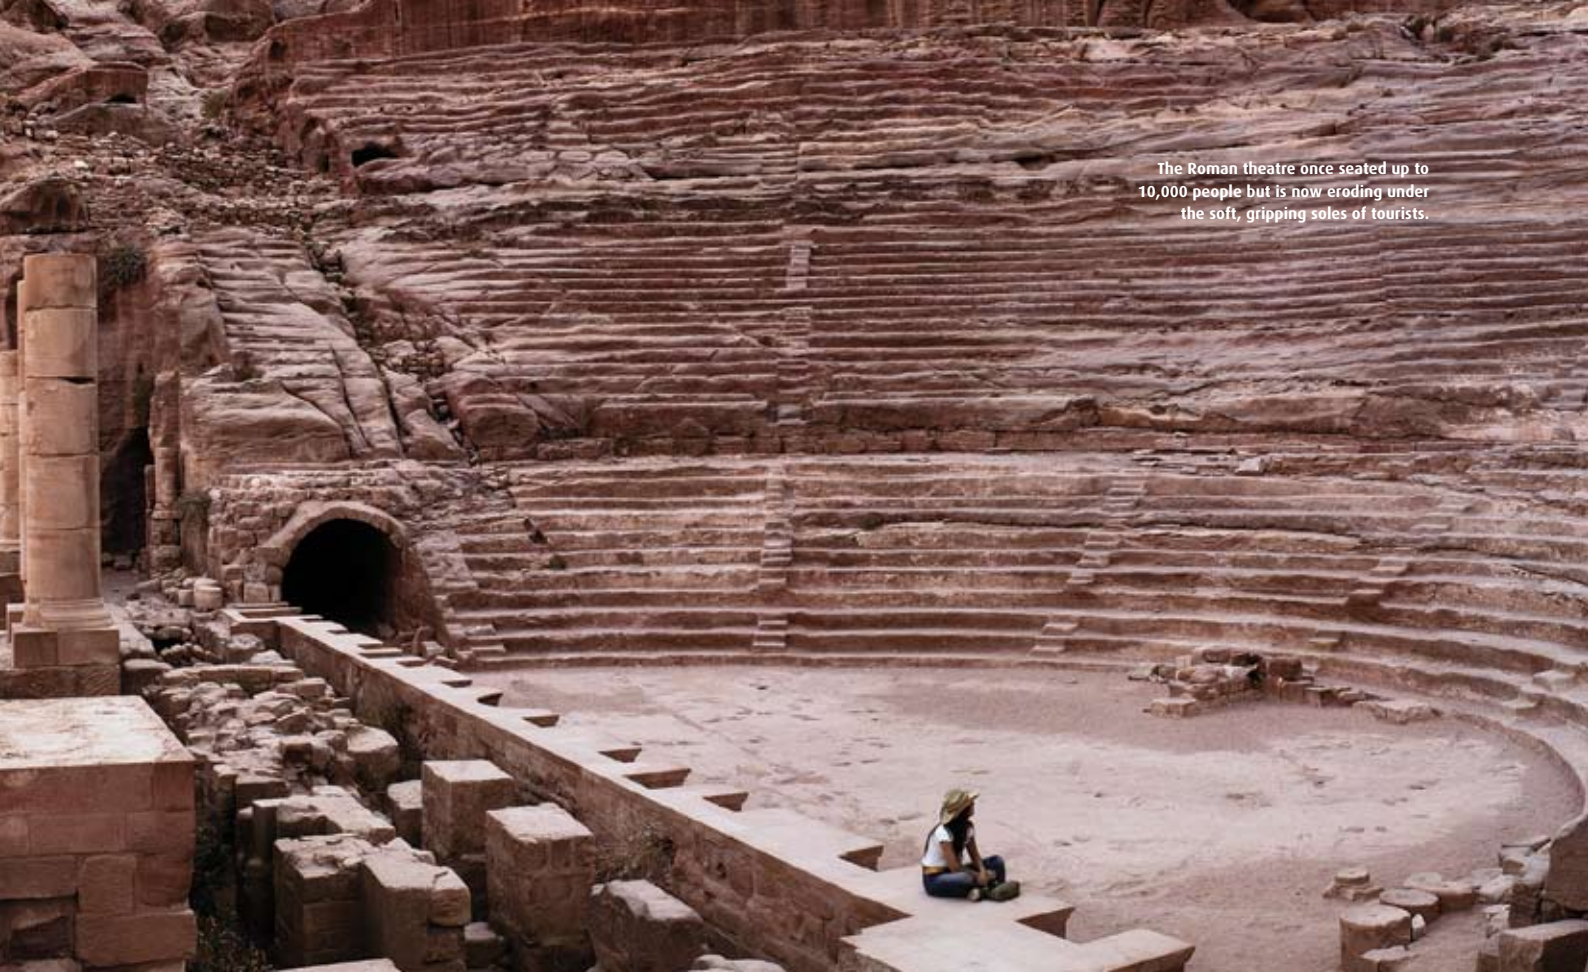
The Roman theatre once seated up to 10,000 people but is now eroding under the soft, gripping soles of tourists.

“Erosion has been enhanced by shoes with soft, gripping soles that increase the relative friction between the visitors’ feet and the sandstone. The accelerated surface recession is especially evident near the orchestra, praecincterae (concentric walkways) and itinerae; parts of the theatre most commonly visited by tourists and tour group operators,” he said.

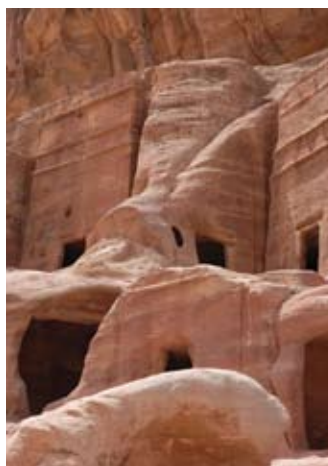
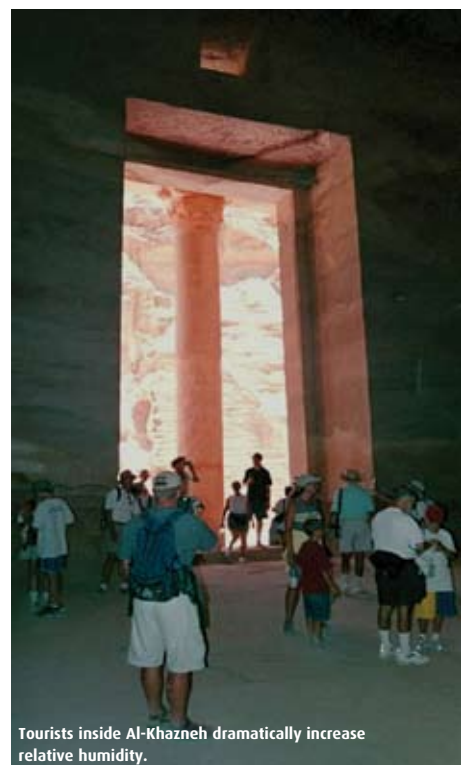
Tourists inside Al-Khazneh dramatically increase relative humidity.

Increased humidity is one of the biggest problems. Environmental monitoring of the interior of Al-Khazneh (conducted repeatedly since 1998) has revealed a very strong relationship between large numbers of visitors and a subsequent rise in relative humidity. Increased moisture in restricted spaces can increase the production of efflorescence (surface salts) in-rock permeability and moisture wicking, and cause a general accelerated weathering and surface recession of sandstone due to particle disaggregation.

“The greatest increases in humidity occur when visitor groups exceeding 25–30 people remain within the tomb for more than five minutes. During peak tourism season, 35 or more people occupy Al-Khazneh almost all day,” said Tom.

“With more than 30 people entering the tomb the humidity jumps from 30 to 60 per cent, which is unacceptable in relation to preservation of the sandstone.”

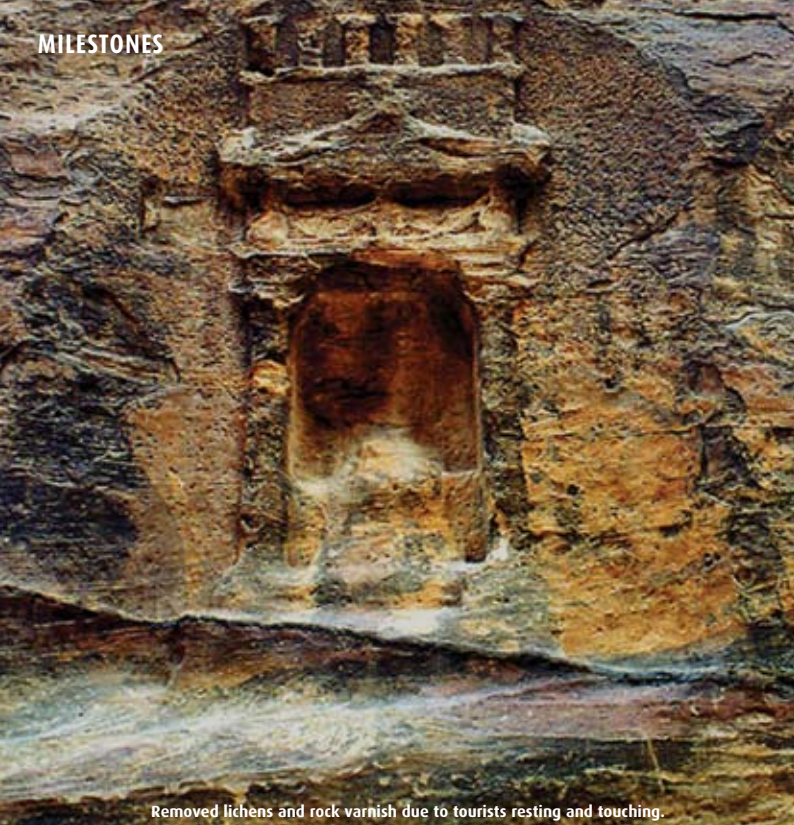
Removed lichens and rock varnish due to tourists resting and touching.

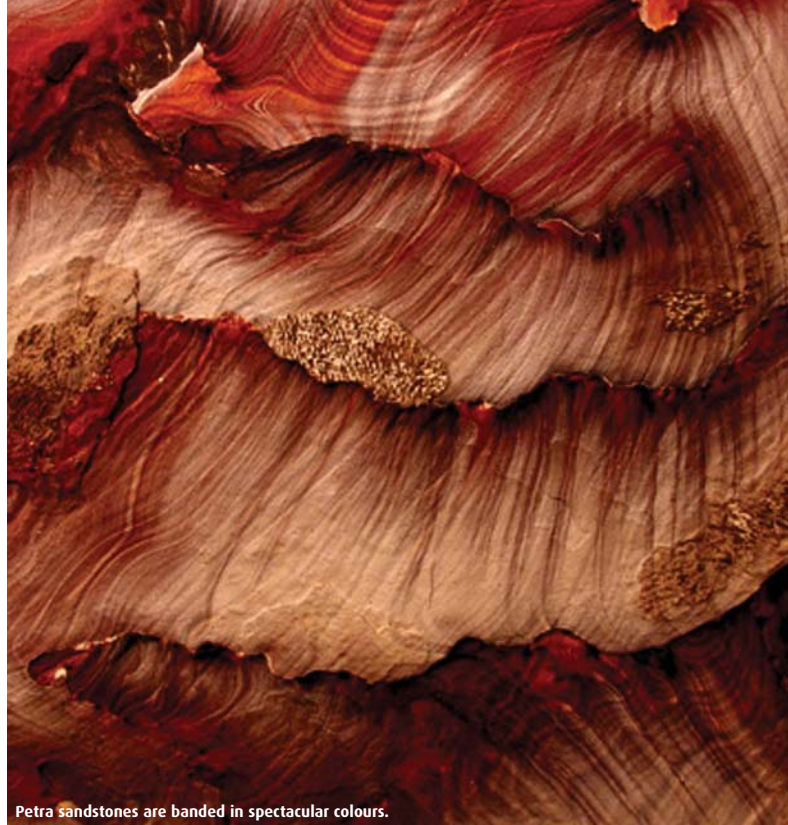
Petra sandstones are banded in spectacular colours.

The research found that sandstone recession is accelerated by insolation (where temperatures exceed 50°C), by carbonate content, and by wide spacing of sandstone sand grains (high matrix-to-clast ratio). Rock properties could also be interpreted on the basis of sandstone colour, since paler calcium-rich and/or high-matrix sandstones are often softer and more friable than darker coloured, iron-rich sandstones. It also revealed that lithologic factors, such as iron oxides and silica in the sandstone matrix, dramatically decrease weathering.

Simple observations supported these findings where the original Roman stonemason tool marks were obvious atop iron-rich sandstone (dark reddish), while large, weathered cavities had developed on the rock areas that were iron poor (pinkish-beige to white).

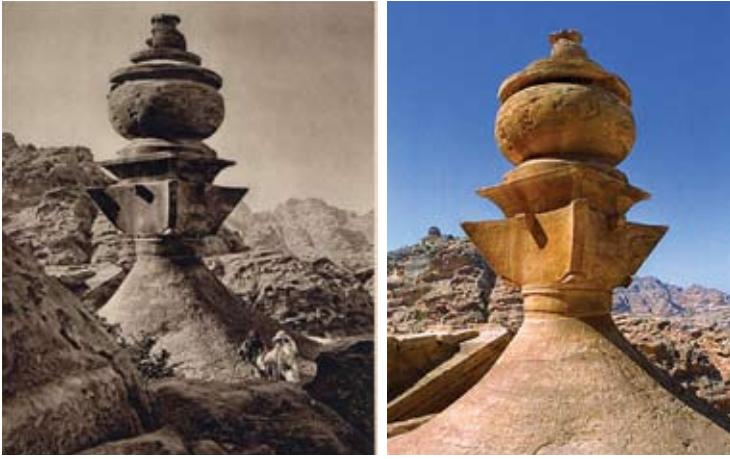
Photographs of the hewn finial on al-Deir (the monastery) shot in 1928 (left) and 2005, show little natural deterioration in the sandstone over the past 75 years.
